Project No. S2439-05-05
June 4, 2025

Subject: SEEPAGE EVALUATION AND MITIGATION RECOMMENDATIONS
CULVER STREET
COLFAX, CALIFORNIA

Culver Street Seepage Evaluation

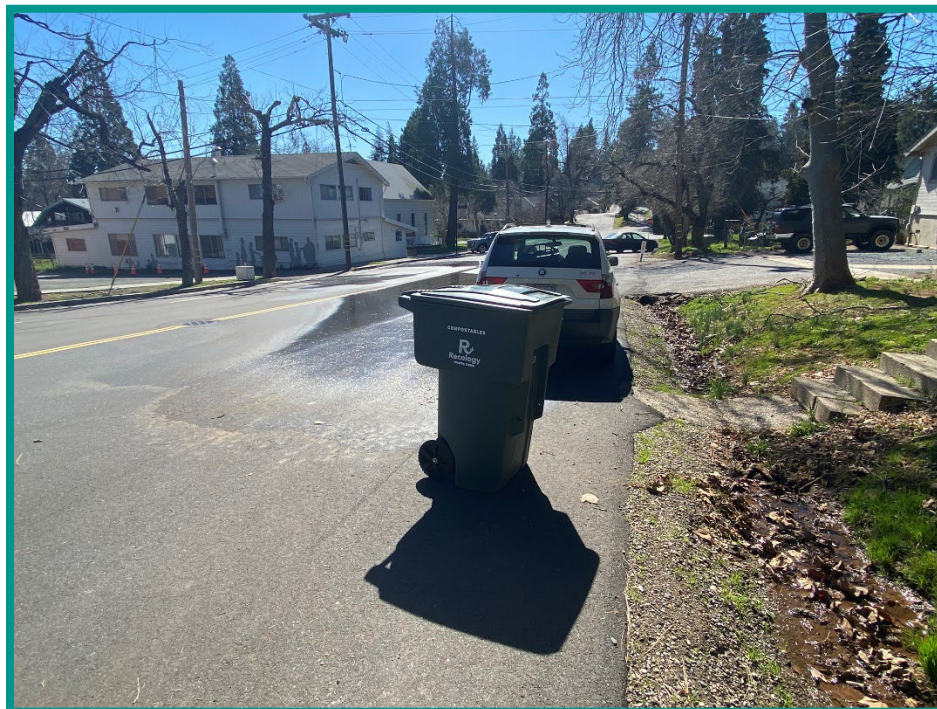
Culver Street, between Grass Valley Street and Church Street, was recently reconstructed in 2025 with a new hot mix asphalt (HMA) pavement section. Following winter rains, seepage was observed emanating from the HMA near the west shoulder of the road (right side in the photo below) and extending to the east and south.

Based on our field observations and the conditions encountered in our borings, it appears that the seepage is the result of shallow subsurface upgradient water that is perched within the soil on the underlying weathered rock. This condition is common in this type of geology (shallow soil over variably weathered rock).

Per the improvement plans for the recent road reconstruction (GHD, 2023), the new pavement section for Culver Street consists of 0.25 feet (3 inches) of HMA over 0.8 feet (10 inches) of aggregate base (AB). However, we understand that the actual pavement section that was constructed may be thinner as the result of a value engineering change which incorporated geosynthetic reinforcement below the AB layer. The revised pavement section reportedly consists of 3 inches of HMA over 6 inches of AB over Tensor InterAx NX850 geogrid. With this configuration, the bottom of the AB layer (approximately 9 inches below the top of the street) is roughly coincident or close to the level of seepage observed in our borings. This suggests that the seepage, which is under some degree of head, is transmitting through the AB and HMA layers daylighting on the pavement surface, as observed.

Based on the conditions observed and the as-built conditions of Culver Street and the associated storm drainage facilities, we recommend installing a subdrain/edge drain along the western side of the road. The subdrain/edge drain should consist of a gravel-filled trench and including a perforated pipe. Figure 3 shows the recommended alignment and details of the drain.

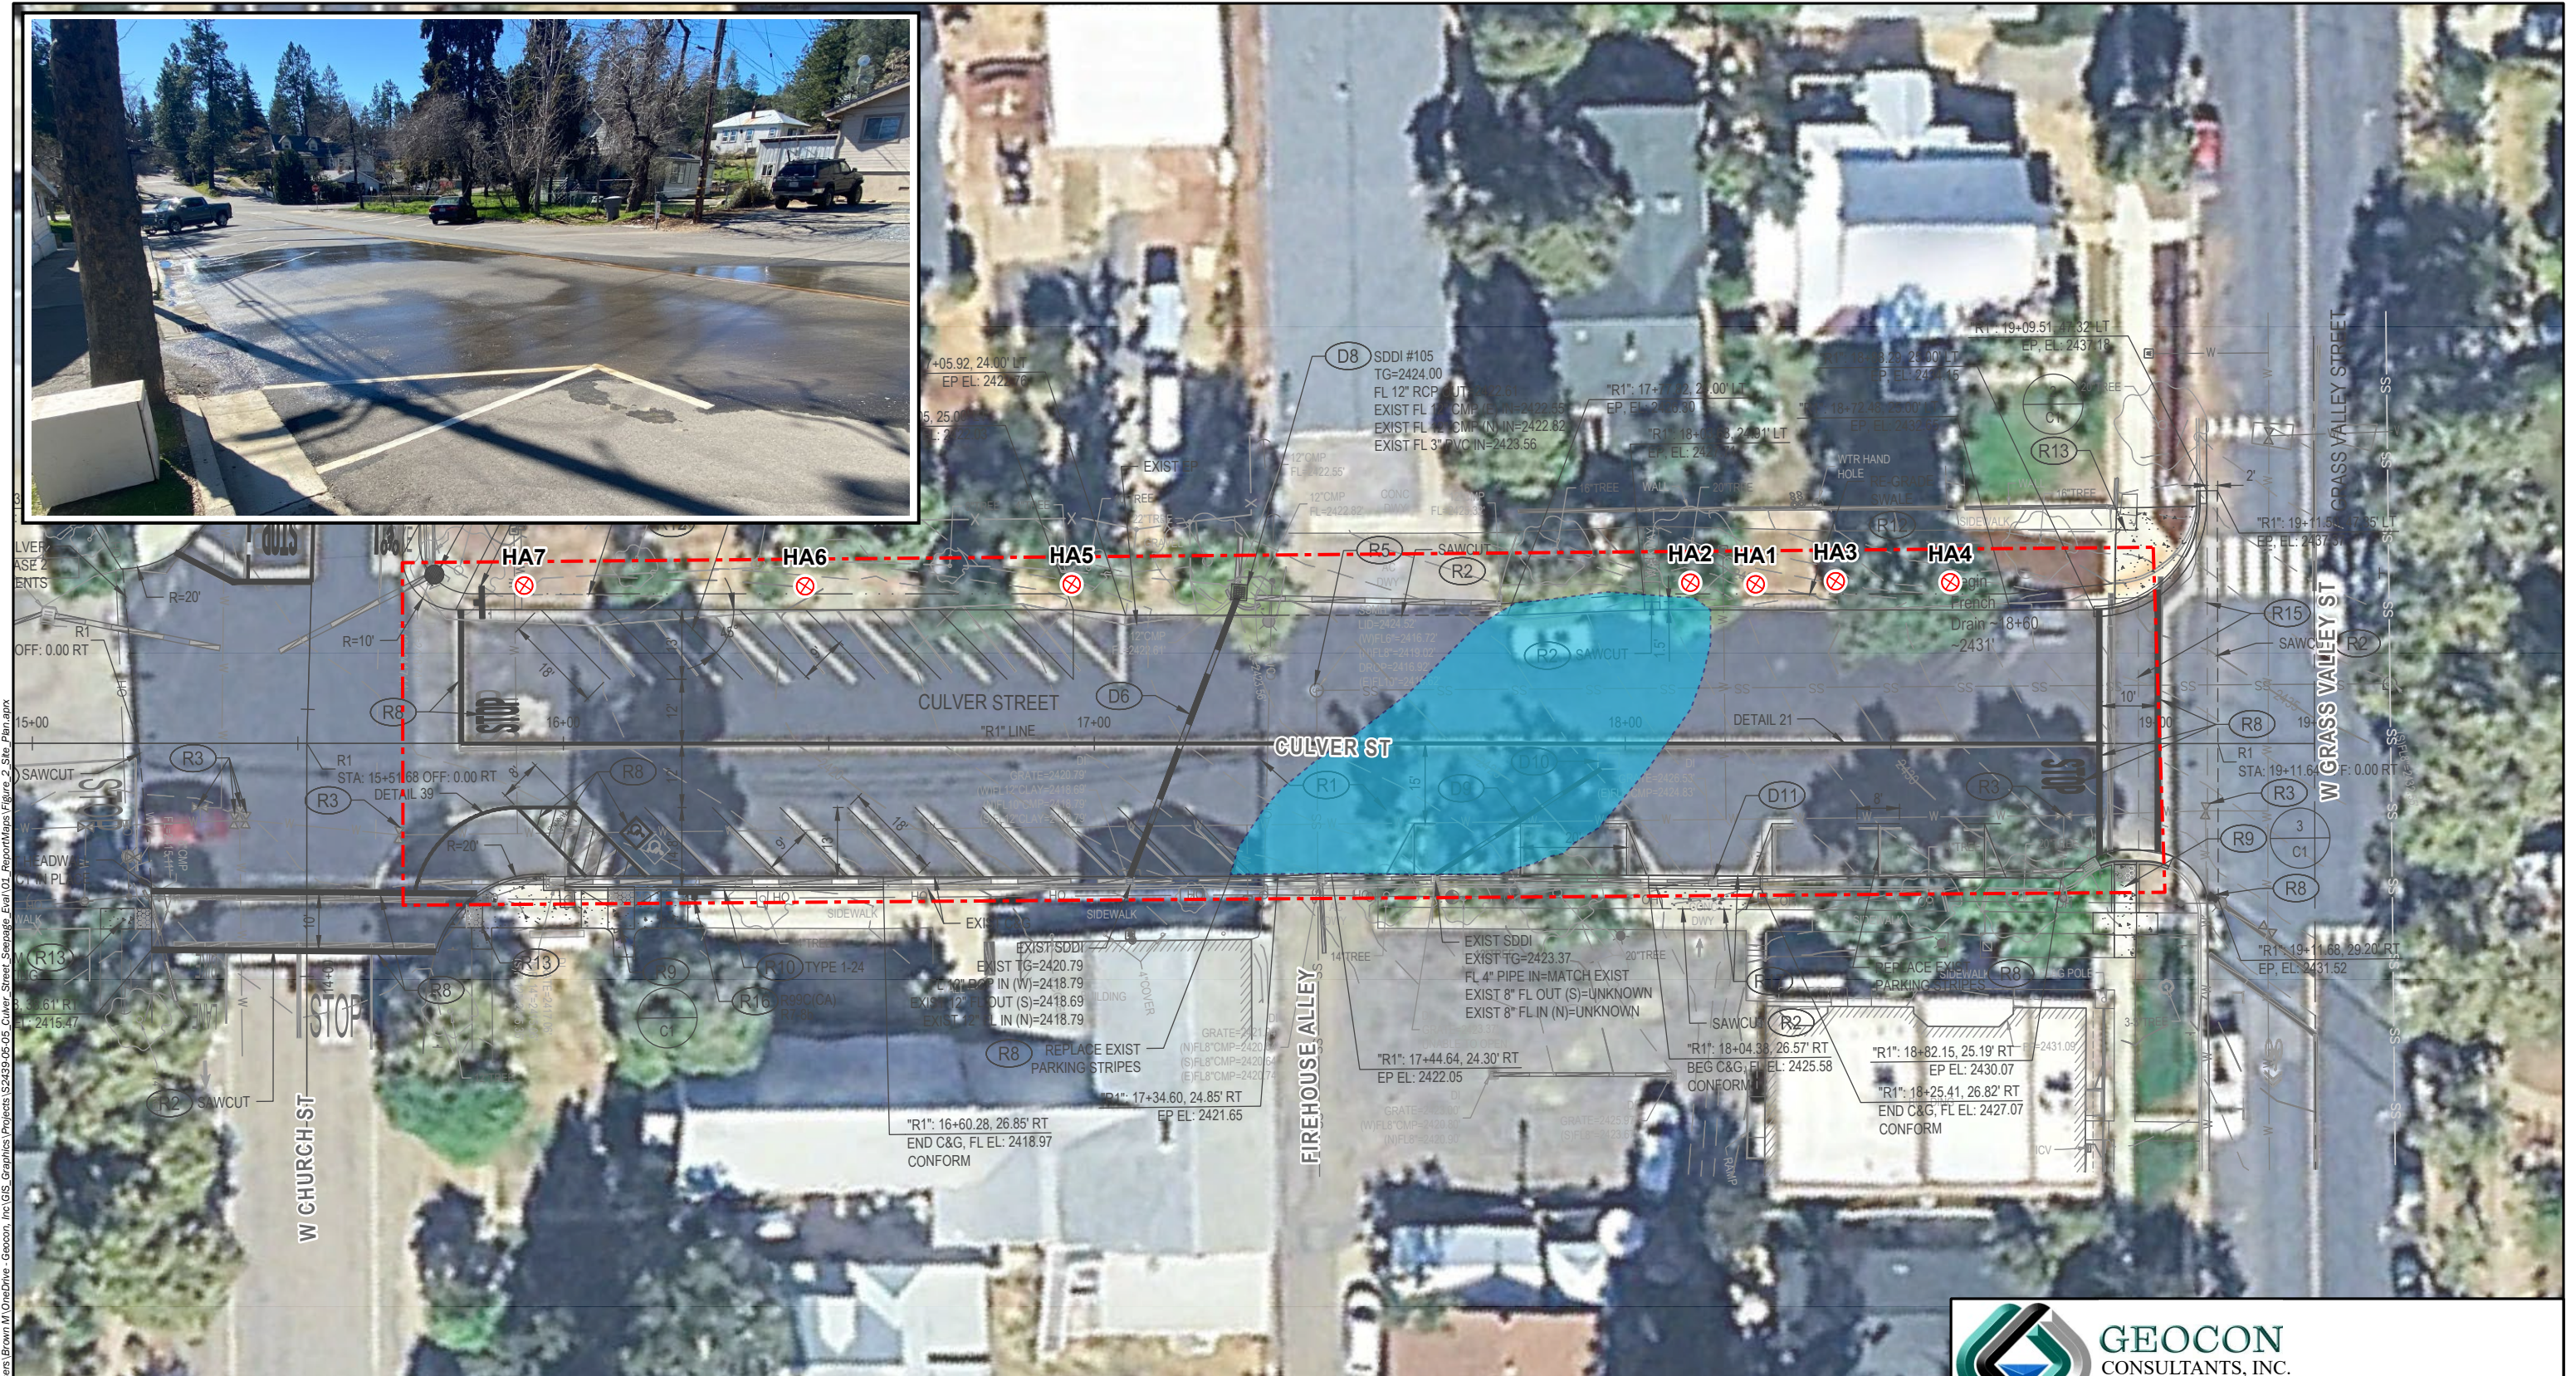
Culver Street Seepage Evaluation		
Culver Street Colfax, California		
SITE PLAN		
S2439-05-05	June 2025	Figure 2

The approximate extents of the seepage (as observed on March 4, 2025) are shown on the Site Plan, Figure 2.

Our field investigation was performed on March 4, 2025. At the site of our field visit, the weather was clear; however, precipitation had occurred within the prior 7 days. During our visit, we observed seepage emanating from the HMA pavement at the approximate location shown on Figure 2. In addition, we observed surface water in the unpaved roadside ditch on the west side of the road.

To evaluate the subsurface conditions and the vertical extent of seepage within and adjacent to the ditch, we excavated seven hand-auger borings at the approximate locations shown on Figure 2. Pertinent details from the borings are summarized in Table 1.

As shown in Table 1, we encountered seepage in 6 of the 7 borings at variable depths. Above the seepage, we encountered soil generally consisting of sandy lean clay with gravel. At or slightly below the seepage, we encountered variably weathered rock. In most areas, we were able to hand-auger 4 to 6 inches into the rock before encountering refusal. In Boring HA4, we were able to auger to a depth of approximately 51 inches.
